## City: things returning to normal at Fifth Street and Hill Avenue

### Rare situation creates flooding, displacement

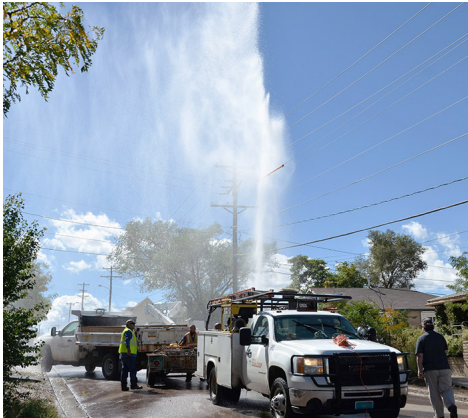
A broken water and sewer line that sent dirty water spewing into the air last week has been repaired, and the situation in the Chihuahuita neighborhood should return to normal by the end of the week.

"We are looking at installing an air relief valve down stream at this point to help manage pressures better," Romero said. "The break at Fifth [Street] and Hill [Avenue] was in a 16-inch ductile iron water main."

Romero said the main was installed in the 1960s, and the break occurred in a weak, corroding section of the line.

"The corrosion, along with the operating pressure, were the causes," he said.

Dennis Romero, the city's water and sanitation director, said city work crews repaired a break by removing a 12- to 14-inch section of the main and replacing it with a new section of ductile iron pipe and sealing it with clamps.

"The splice in the line should work while we look at installing the air relief valve near Mesa Avenue," he said.
